The Design and Construction of the Towers

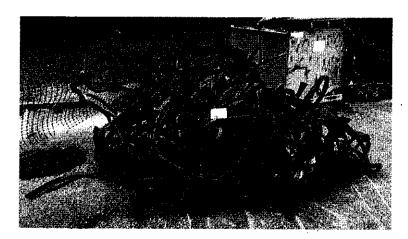
Figure 6-3. Examples of a WTC 1 core column (left) and truss material (right).

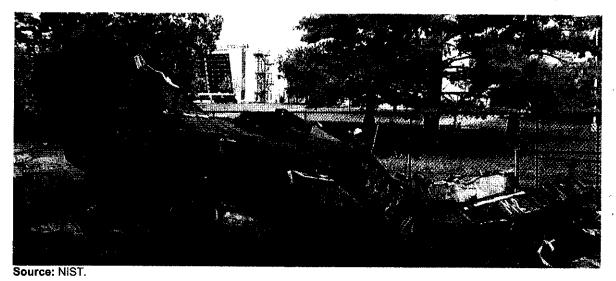
Figure 6-4. WTC 1 exterior panel hit by the fuselage of the aircraft.

For two of the five exterior panels from the impact zone of WTC 1, the general shape and appearance of the recovered pieces matched photographs taken just before the building collapse. Thus, NIST was able to attribute the observed damage to the aircraft impact. NIST also made determinations regarding the connections between structural steel elements:
